# Manhole Inspection Summary

Manhole # S21GG2026MH

Insp Date: **3/12/08 10:26 AM**

**Location** Address: **1117 BELLMORE RD**

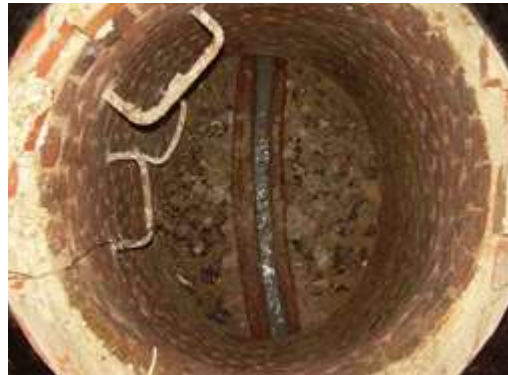
Top View

**Surcharge** ☒ **Evidence Of Surcharge** Depth: **1.5** (ft.) ☐ Active Surcharge Present

Evidence of surcharge - Bench debris.

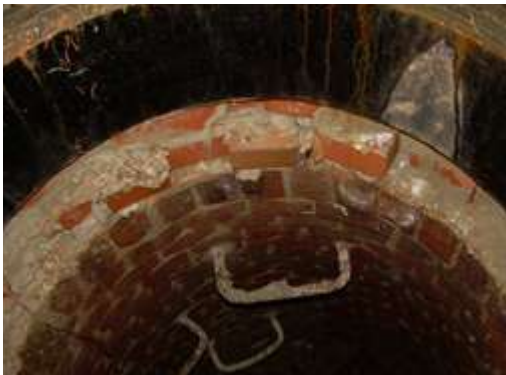
Defect

Condition: ☐ Sound ☐ Cracked ☐ Root Intrusion ☒ **Loose Brick** ☒ **Deteriorated**

Infiltration: ☐ None ☒ **Joint** ☐ Cracks ☐ Mortar ☐ Roots ☒ **Wall**

Frame offset. Adjustment deterioration, loose brick and infiltration.

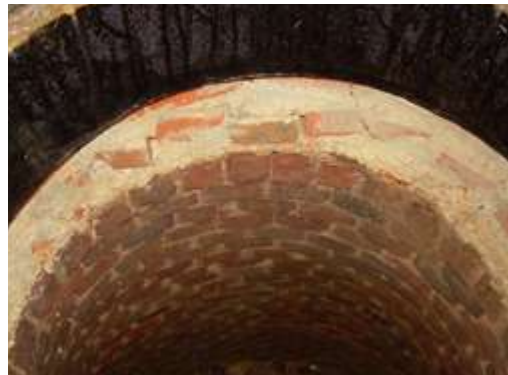
Defect

Frame offset. Adjustment deterioration, loose brick and infiltration - other side.

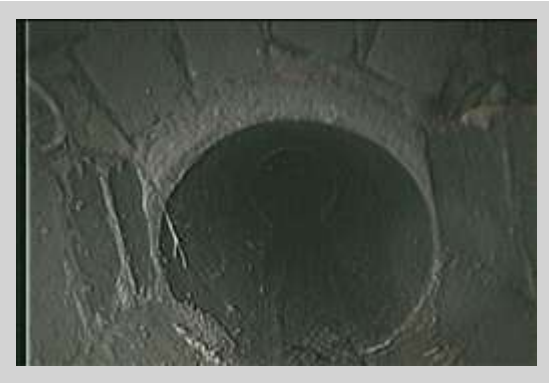
### 8 in. Circular Gravity Sewer Pipe Out @ 12 O'Clock

Infiltration: **None** Pipe Seal Cond: **Roots**

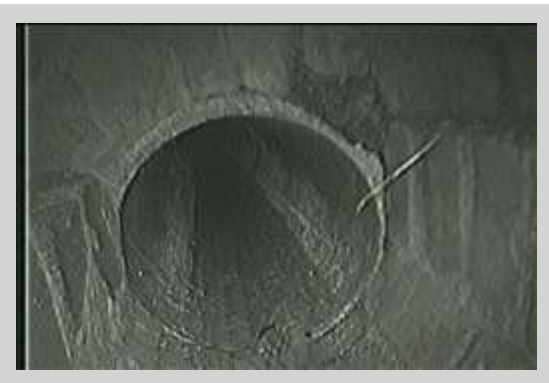
### 8 in. Circular Gravity Sewer Pipe In @ 6 O'Clock

Infiltration: **Evidence** Pipe Seal Cond: **Unknown**
